LOWELL PIERCE DAM

ATCHISON COUNTY, MISSOURI

MO. 11009

**PHASE 1 INSPECTION REPORT
NATIONAL DAM SAFETY PROGRAM**

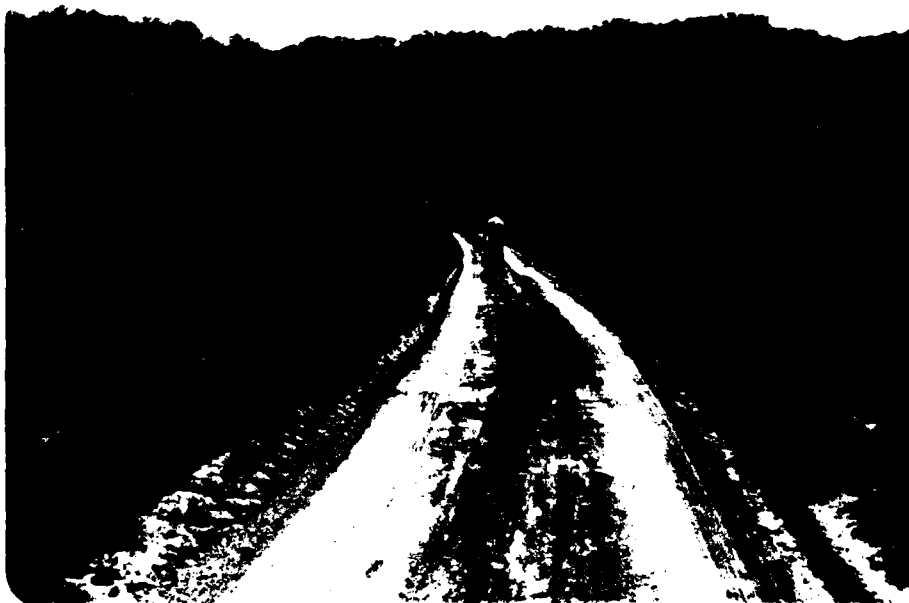
- (3) Crest. The crest serves as an access road across the dam. The right end of the crest is about 1 ft. higher than the left end. No cracks, deformations or significant erosion were noted on the crest. Photo No. 3 shows the crest of the dam.

PHOTO NO. 3 - CREST TAKEN FROM LEFT END.
